ANALIZA OBRADLJIVOSTI LEGURE TITANIJA TA6V**ANALYSIS OF MACHINABILITY OF TITANIUM ALLOY TA6V**

**Begović Edin
Harun Topić**

*University of Zenica
Faculty of Mechanical
Engineering,
Fakultetska 1, Zenica,
B&H*

Professional paper**SUMMARY**

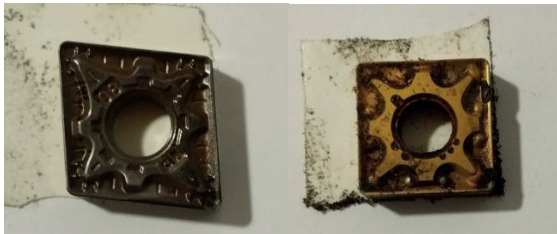
**Figure 2.** Cutting inserts

The data on the cutting inserts are given in Table 2. The cutting inserts and tool holders used during this experiment are shown in Figure 2. and Figure 3.

Designation	Tool 1	Tool 2
Cutting Insert	CNMG-120408-MP	SNMG-120408-MA
Tool Holder	PCLNR 3232P-12	DSSNL 2525M-12
Material	Carbide	Carbide
Manuf.	Korloy	MITSUBISHI
Inscribed Circle dia.	12.7 mm	12.7 mm
Insert Thickness	4.76 mm	4.76 mm
Corner Radius	0.8 mm	0.8 mm
Main Cutting Angle	95 °	45 °
Rake Angle	-5 °	-5 °

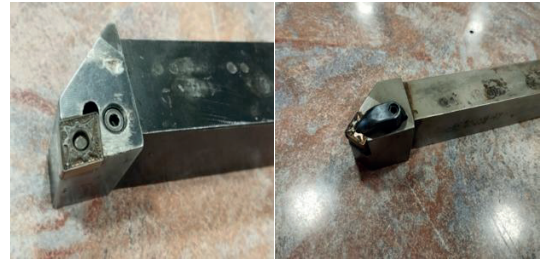
**Figure 3.** Tool holders

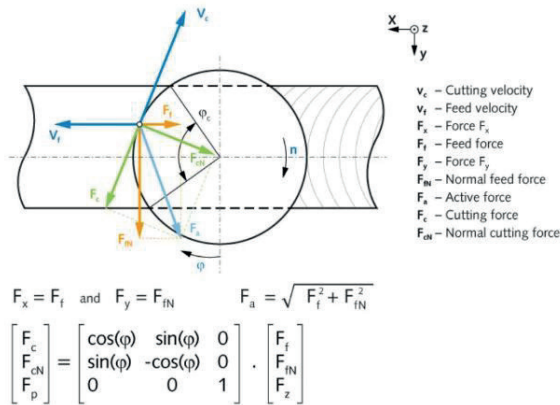
**Figure 4.** Schematic representation of cutting forces [9]

In this experiment, cutting forces were measured for both tools to assess their performance during the machining of TA6V titanium alloy. Cutting forces were measured using a dynamometer. The F_x component represents the feed force, which acts in the direction of the tool feed and contributes to material removal. The F_y component represents the thrust force, which acts perpendicular to the cutting direction and pushing the tool away from the workpiece. The F_z component represents the cutting force, which acts in the cutting direction, opposing the tool's advancement into the workpiece. The cutting forces are listed in Table 3.

A schematic representation of these forces during the machining process is shown in Figure 4. Figure 5 and Figure 6 display cutting force diagrams during machining with both cutting inserts.

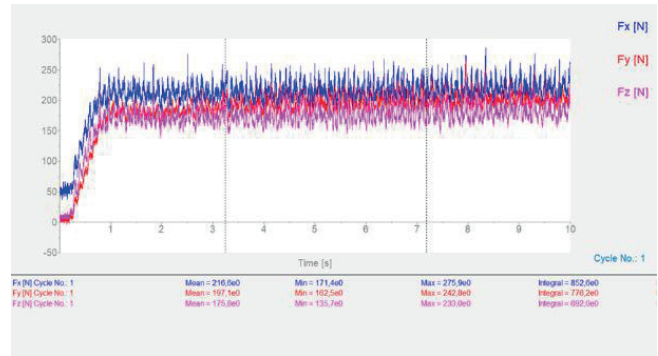
**Figure 5.** Cutting force diagram during machining with CNMG-120408-MP

Cutting force [N]	Tool 1	Tool 2
F_x	216,1	215,2
F_y (mean value)	195	221,8
F_z	175,3	173,8
F_x	278	266
F_y (max. value)	242,8	268,1
F_z	233	218,7
F_x	1,201	1,034
F_y (integral value)	1,804	1,065
F_z	974,6	834,6
F_x	216,5	215,6
F_y (RMS value)	195,4	222,2
F_z	175,8	175,2

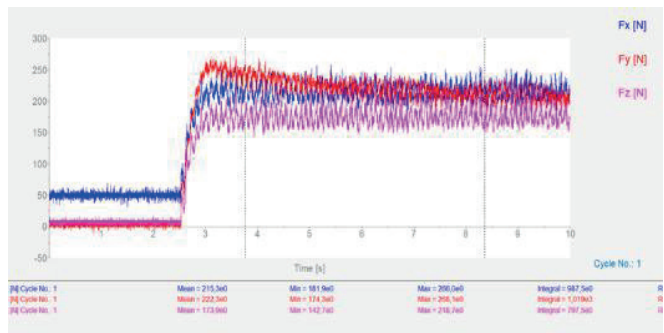
**Figure 6.** Cutting force diagram during machining with DSSNL 2525M-12

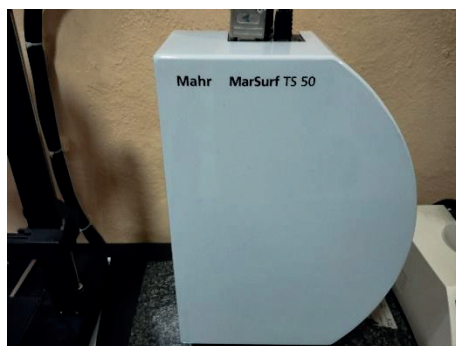
Figure 7. 3D MarSurf optical microscope

A detailed analysis of the CNMG-120408-MP and DSSNL 2525M-12 cutting inserts was performed after machining using a scanning 3D MarSurf microscope. The microscope is shown in Figure 7. The wear on the cutting edge surface after machining was examined. The wear on the CNMG-120408-MP cutting edge is approximately 0.1 mm. The wear on the DSSNL 2525M-12 cutting edge is approximately 0.2 mm. Even though the machining process lasted less than 30 seconds, it still led to considerable wear and tear on the cutting inserts. Detailed views of the cutting insert after machining are shown in Figures 8.1, 8.2, 9.1, and 9.2.

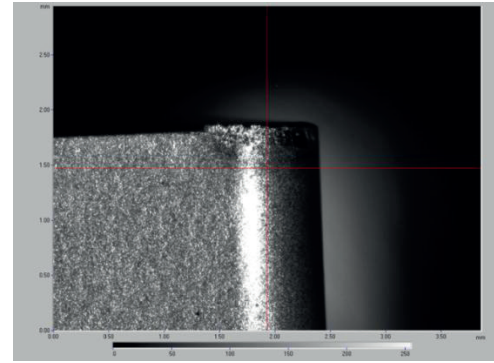
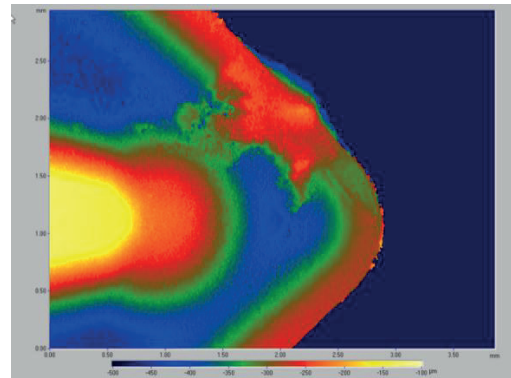
Figure 8.1. Cutting insert CNMG-120408-MP after machining

Figure 8.2. Cutting insert CNMG-120408-MP after machining

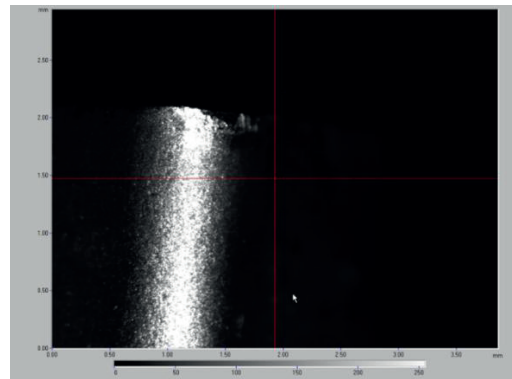
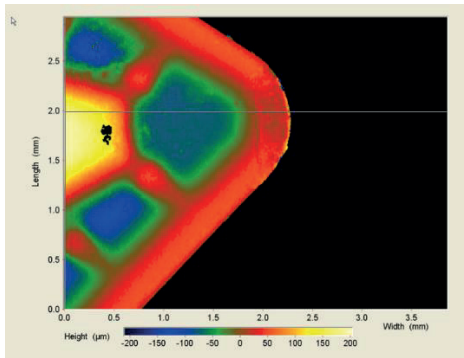
Figure 9.1. Cutting insert DSSNL 2525M-12 after machining

Figure 9.2. Cutting insert DSSNL 2525M-12 after machining

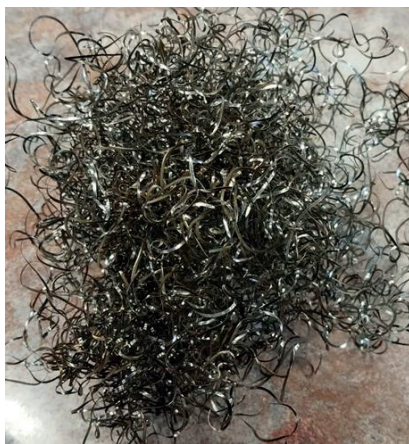
Figure 10. TA6V Chip that was formed after 30 seconds

The machining process was accompanied by the formation of a continuous chip that occupied a large volume and was difficult to remove from the cutting zone. One of the most significant challenges encountered during the machining of TA6V is the formation of continuous chips. These chips occupy a large volume and are difficult to remove from the cutting zone, leading to increased temperatures and hindered heat dissipation. This phenomenon not only intensifies tool wear but also affects the overall efficiency of the machining process. The continuous chip formation is a direct result of the alloy's properties, primarily ductility of material. The TA6V chip that was formed after machining is shown in Figure 10.
