KVALITET OTKOVKA U FUNKCIJI POSTOJANOSTI ALATA PRI OBRADI RUKAVACA TOČKOVA MOTORNIH VOZILA

FORGING QUALITY IN THE FUNCTION OF THE CONSISTENCY OF THE TOOLS IN THE PROCESSING OF THE WHEEL SLEEVES OF MOTOR VEHICLES

Stručni rad

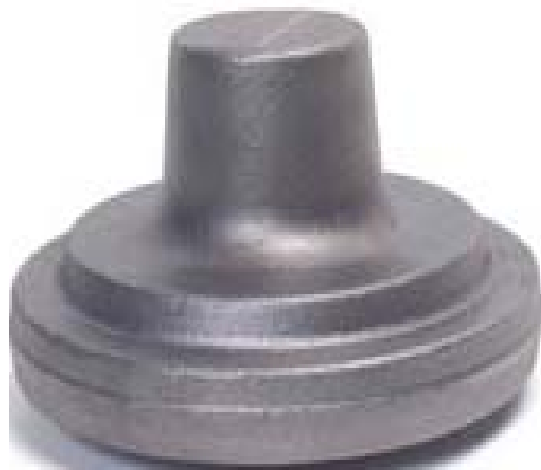
Slika 1. Otkovak za izradu rukavca točka motornog vozila

Figure 1. A forging for the making of wheel sleeves of motor vehicles

Otkovak rukavca motornih vozila, koji je predstavljen na slici 1., dobija se kovanjem u toplom stanju postupkom kovanja u ukovnjima. Masa otkovka je cca 1,4 kg i oblikuje se na kovačkom čekiću prostog dejstva.

The forging of the motor vehicle sleeve, which is presented in Figure 1., is obtained by forging in a warm condition by the procedure of hammering in forging molds. The mass of the forging is approx. 1.4 kg and it is done on a hammer with free action. The material is a middle-carbon steel of special steel structure, which is by its characteristics the closest steel EN-1C55 which corresponds to the steel of the mark DIN-C55. However, in order to improve certain characteristics, some elements were added in smaller percentages. The exact chemical composition, of steel for making forgings is given in Tables 1 and 2. It should be noted that there are somewhat different chemical compositions of group A and group B forgings because they have different producers.

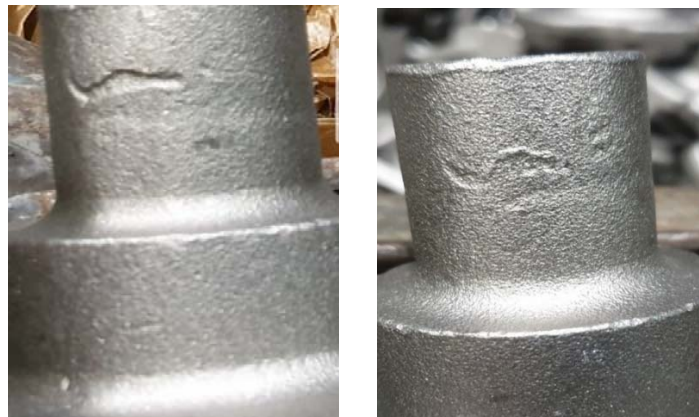
Slika 2. Izgled otkivka sa greškama otkrivenim vizualnom metodom

Figure 2. The appearance of a forging with errors detected with the visual method

Najjednostavnija metoda kontrole kvaliteta otkivaka je vizuelna metoda. Ona otkriva nepravilnosti otkivaka, a primjeri grešaka koje se mogu otkriti vizuelnom metodom dati su na slici 2.

As stated earlier, during the forging process, various oxides on the surface of the forging are formed. Oxides are created during the forging process and none of the procedures for their removal are completely effective. Therefore, it is necessary to constantly control the production of forgings and to eliminate various irregularities. Each occurrence of errors has multiple adverse effects on the process of fabrication of the wheel sleeves and on the quality of the finished sleeve. The specificities of the forging process indicate that the process itself is very difficult to follow. A common occurrence is getting forgings with errors. The least negative consequences occur when errors are detected before cutting. [2] Considering that it is a large series of forging production, it is difficult to apply some more complex methods of controlling each forging. The simplest method of controlling the quality of the forgings is the visual method. It reveals the irregularities of the forgings and examples of errors that can be detected by the visual method are given in Figure 2.

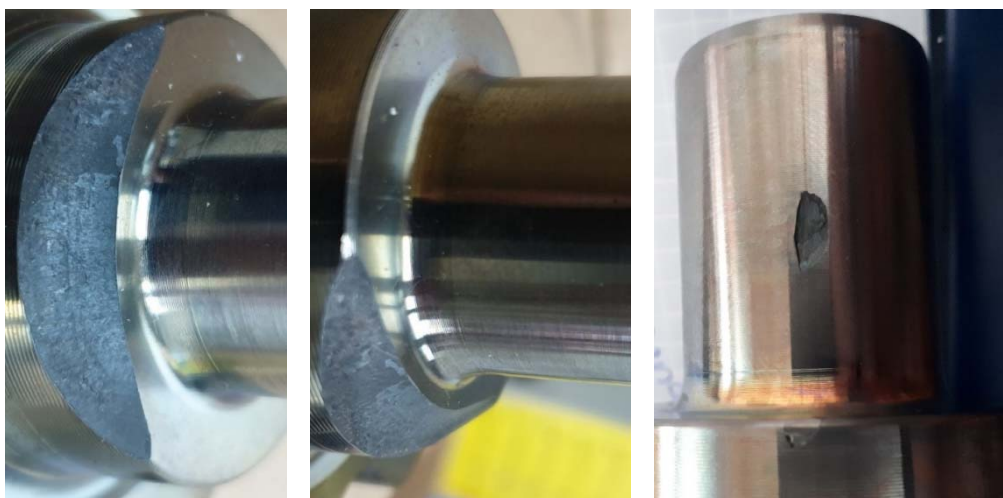
Slika 3. Izgled dijelova sa greškom nakon obrade struganjem

Figure 3. The appearance of parts with error after scraping processing

Pri zahvatu reznog klina i otkivka koji u sebi ima razne oksidne uključke obavezno dolazi do loma reznog klina alata. U ovom slučaju to je strugarski nož sa izmjenjivom tvrdom pločicom. Na slici 3 su prikazani dijelovi sa takvom greškom nakon zahvata uzdužnog struganja.

Ako se pažljivo pogleda hrapavost površine zahvata prije nego što rezni klin dodirne uključak i nakon što je rezni klin došao u zahvat sa uključkom, može se zaključiti da je došlo do loma vrha reznog klina jer se i vizuelno uočavaju „brazde“ na dijelu površine nakon zahvata, što je posljedica loma reznog klina, odnosno, posljedica promjene geometrije reznog klina.

If one carefully looks at the roughness of the surface of the engagement before the cutting wedge touches the inclusion and after the cutting wedge has come in contact with the inclusion, it can be concluded that there was a break of the tip of the cutting wedge because of the visible "furrows" on the part of the surface after the procedure, which is a consequence of a breakage of the cutting wedge, that is, the consequence of the change in the geometry of the cutting wedge. One such procedure leads to the stopping of the machining process because the said part is machined on the CNC machines in the automated unfolding of the process, and it is necessary to replace the tool (cutting blades or install another tile if all its tips are damaged).

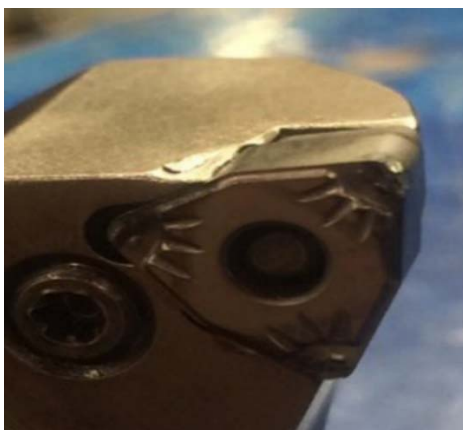
Slika 4. Izgled polomljenog vrha pločice
Figure 4. The appearance of the broken top of the tile

Na slici 4. su prikazane neke od pločica koje su bile u zahvatu sa takvim otkovkom gdje se vidi izgled polomljene pločice. Od čega zavisi veličina loma pločice je teško utvrditi.

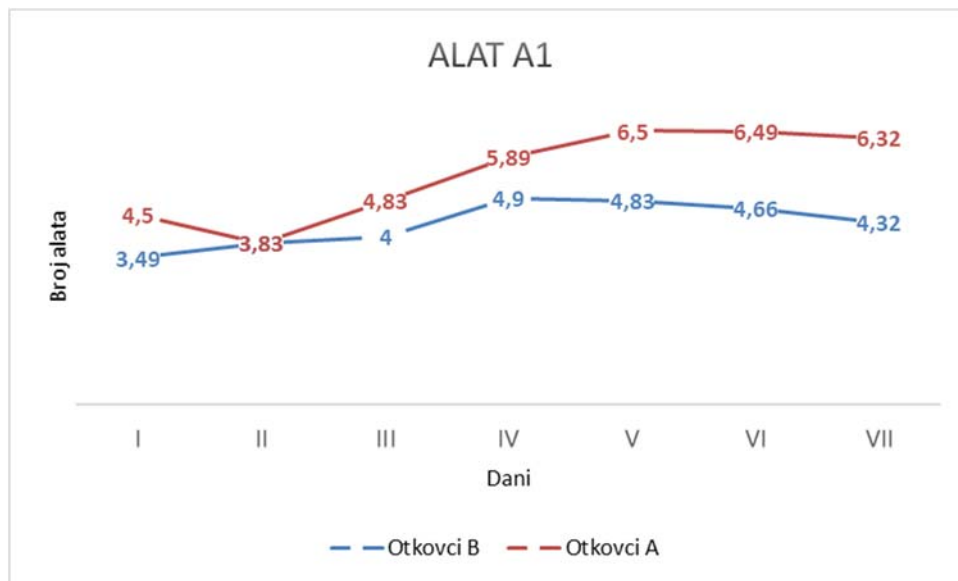
Grafikon 1. Prikaz dnevne potrošnje alata A1 za obradu otkovaka
Chart 1. Displaying the daily consumption of the A1 tool for processing forgings

Na grafikonima 1, 2, 3 i 4 su prikazane dnevne potrošnje alata za obradu otkovaka iz grupe A i B. Vidi se da je dosta veća potrošnja alata iz grupe B iako je veoma mala razlika u hemijskom sastavu materijala. Analiza je rađena na osnovu ukupne istrošenosti alata, što podrazumijeva i habanje pri obradi otkovaka koji nemaju izražene nepravilnosti u vidu uključaka.

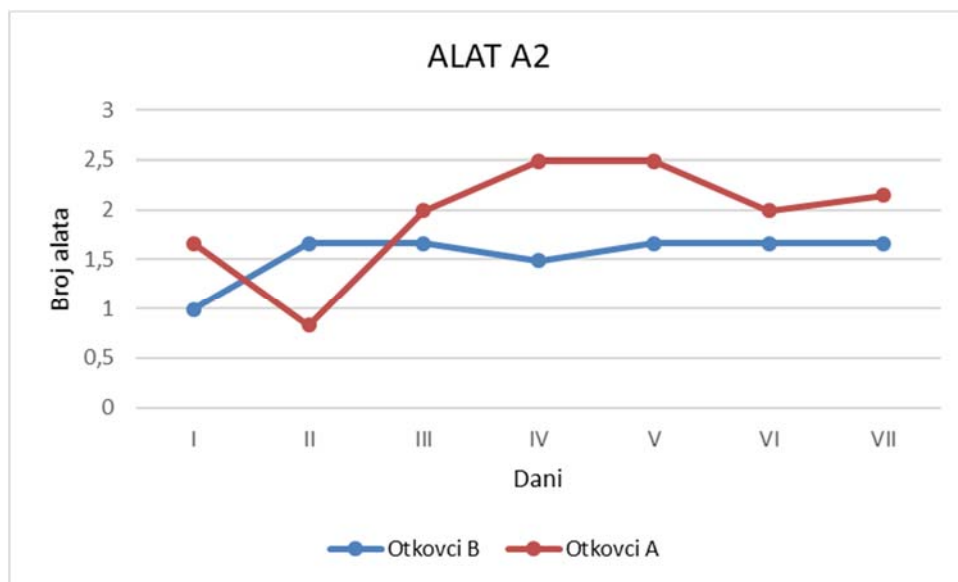
Grafikon 2. Prikaz dnevne potrošnje alata A2 za obradu otkovaka
Chart 2. Display of the daily consumption of the A2 tool for processing the forgings

Na grafikonu 2 je vidljivo da je drugi dan potrošnja alata pri obradi otkovaka iz grupe A manja od potrošnje alata za obradu otkovaka iz grupe B. To se desilo zato što se javio otkovak sa greškom koji je prouzrokovao lom dva vrha rezne pločice.

Chart 2 shows that the second day the consumption of tools for processing Group A forgings is less than the consumption of tools for processing group B forgings. This happened because a forging with a fault caused the fracture of two tops of the cutting tile.

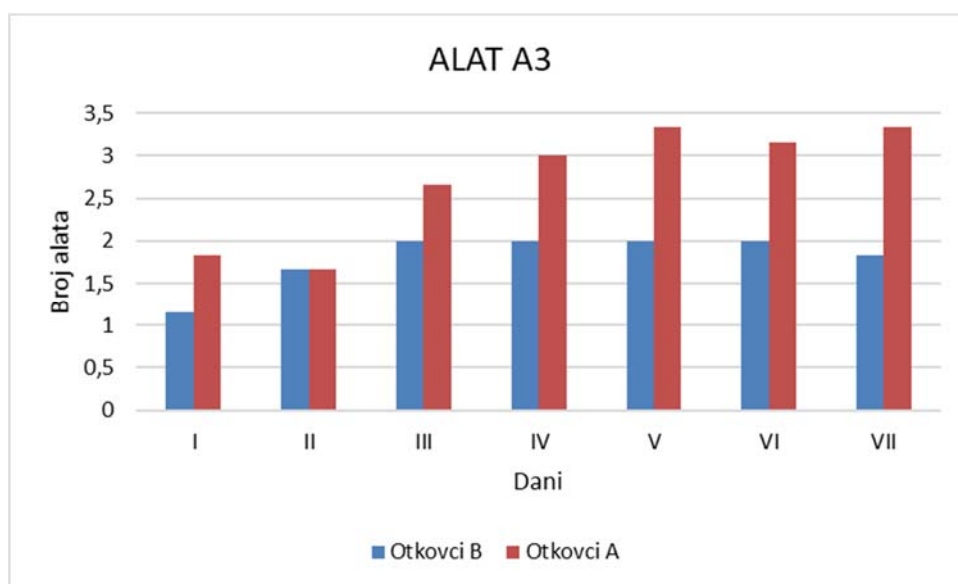
Grafikon 3. Prikaz dnevne potrošnje alata A3 za obradu otkovaka

Chart 3. Display of the daily consumption of the A3 tool for processing the forgings

Na trećem grafikonu se vidi da je drugog dana bila ista potrošnja alata iz obje serije, i tog dana došlo je do pojave otkovka sa greškom.

The third chart shows that in the second day the consumption of tools from both series was the same, and on that day there was an error with the forging.

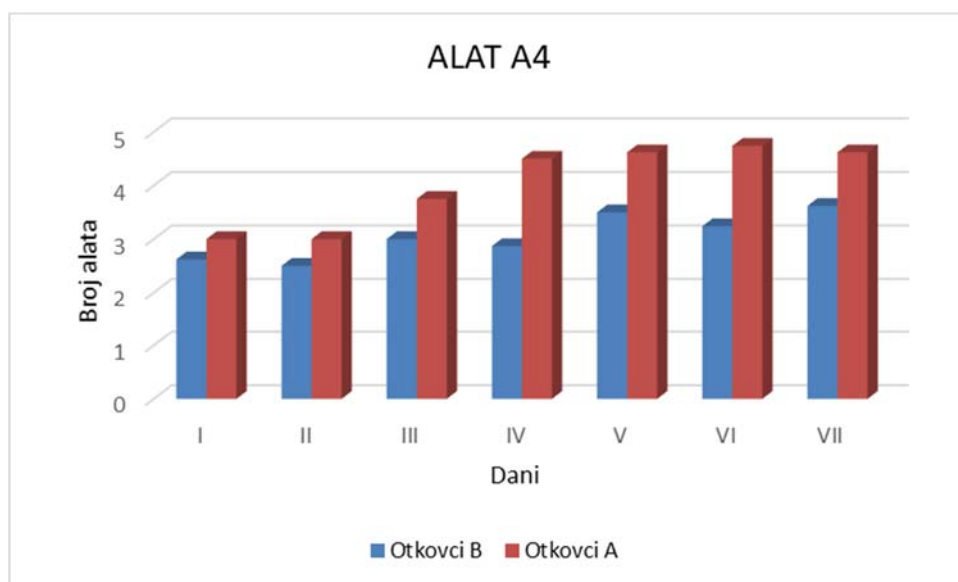
Grafikon 4. Prikaz dnevne potrošnje alata A4 za obradu otkovaka

Chart 4. Display of the daily consumption of the A4 tool for processing the forgings

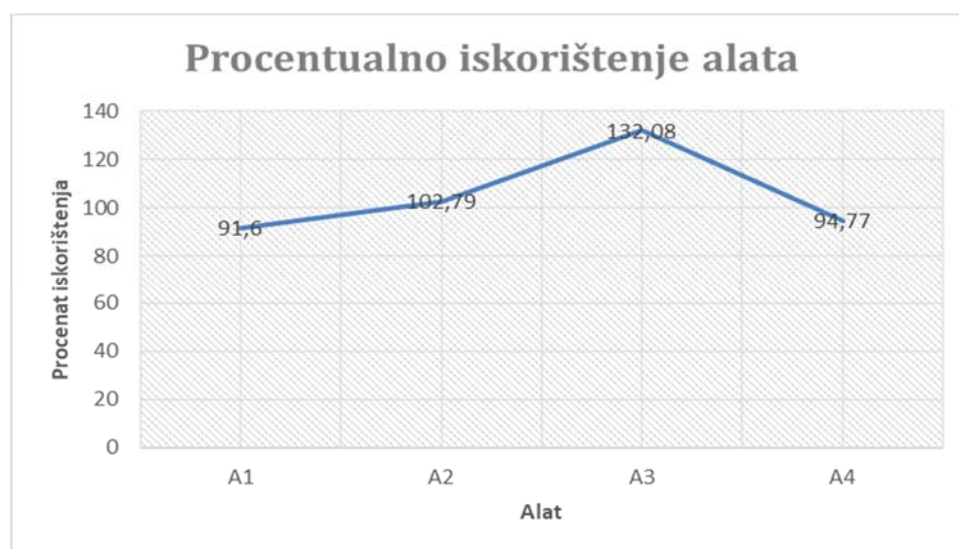
Grafikon 5. Procentualno iskorištenje alata

Chart 5. Percentage of tool utilization

Na grafikonu 5 je prikazano procentualno iskorištenje alata u posmatranom periodu od sedam dana.

Chart 5 shows the percentage utilization of tools in the observed seven-day period.
