# FINDING THE ACTUAL CAUSES OF HYDRAULIC CYLINDER FAULT

### Darko Lovrec, Vito Tič

The focus of the paper is searching for the actual cause of the frequently repeated failure of the closing cylinder on the plastic blow-moulding machine. The solution of the problem presented was the use of a combined approach: analysis of wear particles in the oil, and measurement of the accuracy of the motion of the cylinder's piston rod.

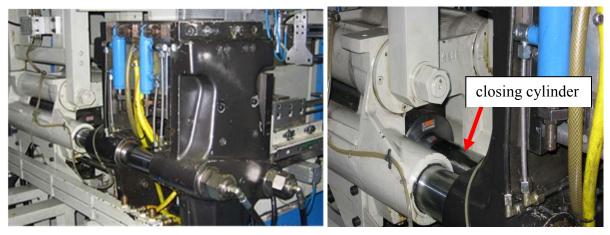
Figure 1. Closing unit together with tool (left) and closing cylinder (right)

On the blow-moulding machine for production of plastic canisters with volume up to 5 L, a fault on the closing part of the machine occurred periodically. Opening and closing of the tools is carried out by means of a hydraulic cylinder with dimension of 125/80 (Figure 1). Based on the detailed inspection of the entire machine, especially the hydraulic components and the machine control system it was found out, that the cause of the fault could be in the hydraulic cylinder, because after replacing the hydraulic cylinder with the new one, the machine was working properly. But after a certain time, the same error occurred again.

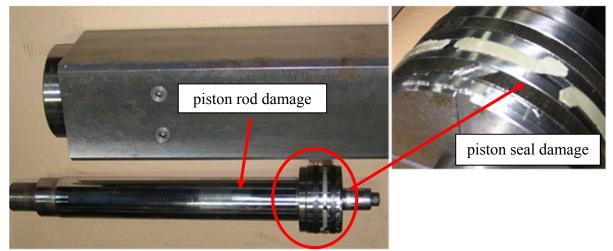
Figure 2. Damages on the piston rod and the seal

A repetitive errors lead to a longer standstill of the machine, due to the purchase and installation of the new cylinder, causing a huge loss of production downtime. After dismantling, disassembly and detailed inspection of the cylinder, the consequences of wear on the inner surface of the cylinder were observed - the damaged surface of piston rod, cylinder (scratches), and damaged seals – Figure 2.

Due to the extensive damages on hydraulic cylinder (see Figure 2): visible metal parts of wear, damaged seal... it is absolutely essential to check the condition of the hydraulic fluid, not only the cleanliness level of hydraulic fluid, but also the other parameters, for example, water content, hard particles... - a complete laboratory analysis of basic properties.

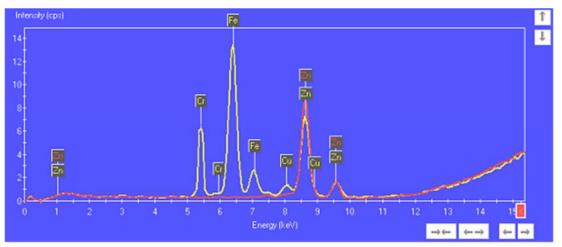
*Figure 4. Comparison of fresh (red spectrum, ISO 4406: 22/21/18) and used-up hydraulic oil (yellow spectrum, ISO 4406: >24/24/19*

In the present case additionally X-ray fluorescent spectrometry (XRF) was carried out. The result of the XRF analysis is a spectrum, with energy on x-axis - regarding the element (material) and its intensity on y-axis. Using a

computer programme we can directly compare two spectra of the same fluid - the fresh and already used-up, heavy contaminated the same type of hydraulic oil - Figure 4.

On both spectra presence of wear particles respectively metal in hydraulic oil is evident. In case of fresh oil the particles of Zinc (Zn) are observable present, in case of used-up oil but beside Zinc as well Iron (Fe), Chromium (Cr) and Copper (Cu). It is known that Zinc is present as an oil additive element, therefore present on both spectra. Comparing their peaks by used-up oil, its intensity is lower, because of consumption this additive in oil.

The presence of all the other elements, as a deviations in intensity the spectra, are only the consequence of the wear processes. This information represents a very useful directive to look for place or component, where are they generated.

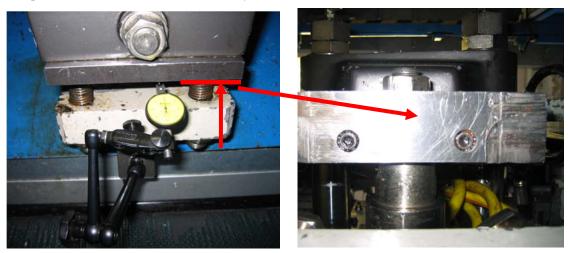
Figure 6. Incorrect adjustment of the support-screw (left) and strong signs of wear (right)

On the basis of the measurements, it was found that a larger transverse displacement of the piston rod occurs at the end of the movement, when the tool is already closed and leans on the support point - in this case, on adjustable screw. The movement was inaccessible to 1,125 mm, which already led to the wear of the surface of the piston rod (visible to the naked eye) and probably also the interior of the cylinder (the presence of Fe in the oil).

Why is the increased displacement of the piston rod near the end position? The reason is the incorrect adjustment of the support-screw, which also showed strong signs of wear - Figure 6.

Solving the problem was, in the end, quick, simple and cheap: correct, reinstalling the support screw and re-control with the measurement prevented the worst: further damage of hydraulic cylinder and stopping the machine.
