ANALIZA OŠTEĆENJA KOČIONOG DISKA KOORDINATNOM MJERNOM MAŠINOM I 3D CAD MODELIRANJEM

ANALYSIS OF DISC BRAKE FRACTURE USING COORDINATE MEASURING MACHINE AND 3D CAD MODELING

Focus of this paper is to determine the main cause of brake disc fracture using coordinate measuring machine Zeiss Contura G2 and 3D CAD software Solidworks. The analysis was carried out on a brake disc of Mercedes Atego truck, on which two radial cracks were spotted (Figure 1).

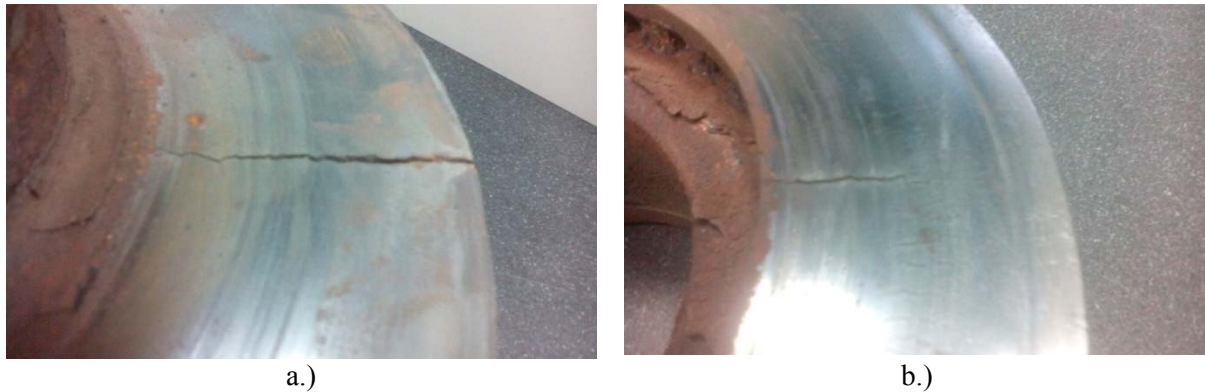
Slika 1. Pukotine na kočionoj površini diska (a – vanjska površina, b – unutrašnja površina)
Figure 1. Cracks on braking surface of the disc (a – inner surface, b – outer surface)

The occurrence of cracks on brake disc indicates that disc should be replaced. Cracks on the disc cause impacts during braking, uneven heating and rapid wearing of braking surface, and all this finally causes the cracks to rapidly expand in depth of material. If brake disc with crack is not replaced in a timely manner, the disc often
