## KVALITET OTKOVKA U FUNKCIJI POSTOJANOSTI ALATA PRI OBRADI RUKAVACA TOČKOVA MOTORNIH VOZILA

### FORGING QUALITY IN THE FUNCTION OF THE CONSISTENCY OF THE TOOLS IN THE PROCESSING OF THE WHEEL SLEEVES OF MOTOR VEHICLES

*Stručni rad*

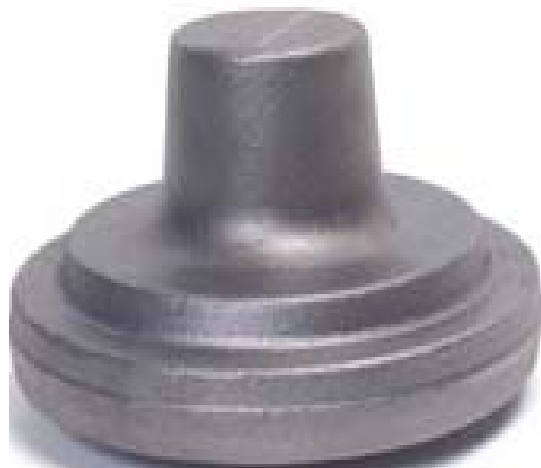
*Slika 1. Otkovak za izradu rukavca točka motornog vozila*

*Figure 1. A forging for the making of wheel sleeves of motor vehicles*

Otkovak rukavca motornih vozila, koji je predstavljen na slici 1., dobija se kovanjem u toplom stanju postupkom kovanja u ukovnjima. Masa otkovka je cca 1,4 kg i oblikuje se na kovačkom čekiću prostog dejstva.

The forging of the motor vehicle sleeve, which is presented in Figure 1., is obtained by forging in a warm condition by the procedure of hammering in forging molds. The mass of the forging is approx. 1.4 kg and it is done on a hammer with free action. The material is a middle-carbon steel of special steel structure, which is by its characteristics the closest steel EN-1C55 which corresponds to the steel of the mark DIN-C55. However, in order to improve certain characteristics, some elements were added in smaller percentages. The exact chemical composition, of steel for making forgings is given in Tables 1 and 2. It should be noted that there are somewhat different chemical compositions of group A and group B forgings because they have different producers.

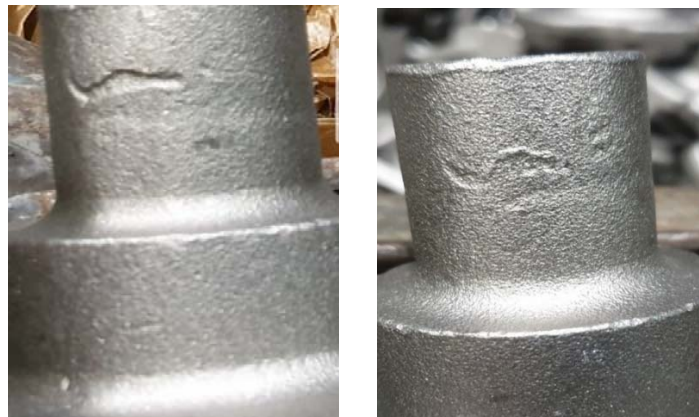
*Slika 2. Izgled otkivka sa greškama otkrivenim vizualnom metodom*

*Figure 2. The appearance of a forging with errors detected with the visual method*

Najjednostavnija metoda kontrole kvaliteta otkivaka je vizuelna metoda. Ona otkriva nepravilnosti otkivaka, a primjeri grešaka koje se mogu otkriti vizuelnom metodom dati su na slici 2.

As stated earlier, during the forging process, various oxides on the surface of the forging are formed. Oxides are created during the forging process and none of the procedures for their removal are completely effective. Therefore, it is necessary to constantly control the production of forgings and to eliminate various irregularities. Each occurrence of errors has multiple adverse effects on the process of fabrication of the wheel sleeves and on the quality of the finished sleeve. The specificities of the forging process indicate that the process itself is very difficult to follow. A common occurrence is getting forgings with errors. The least negative consequences occur when errors are detected before cutting. [2] Considering that it is a large series of forging production, it is difficult to apply some more complex methods of controlling each forging. The simplest method of controlling the quality of the forgings is the visual method. It reveals the irregularities of the forgings and examples of errors that can be detected by the visual method are given in Figure 2.

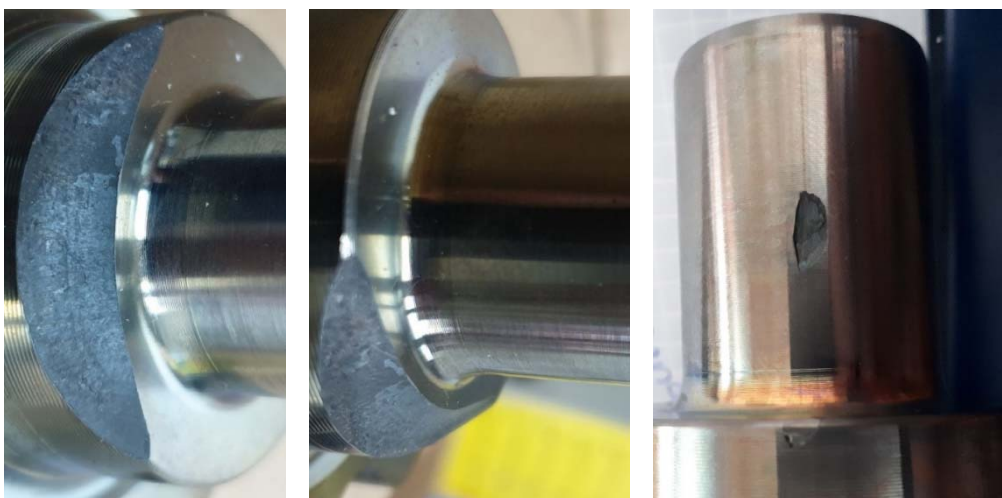
*Slika 3. Izgled dijelova sa greškom nakon obrade struganjem*

*Figure 3. The appearance of parts with error after scraping processing*

Pri zahvatu reznog klina i otkivka koji u sebi ima razne oksidne uključke obavezno dolazi do loma reznog klina alata. U ovom slučaju to je strugarski nož sa izmjenjivom tvrdom pločicom. Na slici 3 su prikazani dijelovi sa takvom greškom nakon zahvata uzdužnog struganja.

Ako se pažljivo pogleda hrapavost površine zahvata prije nego što rezni klin dodirne uključak i nakon što je rezni klin došao u zahvat sa uključkom, može se zaključiti da je došlo do loma vrha reznog klina jer se i vizuelno uočavaju „brazde“ na dijelu površine nakon zahvata, što je posljedica loma reznog klina, odnosno, posljedica promjene geometrije reznog klina.

If one carefully looks at the roughness of the surface of the engagement before the cutting wedge touches the inclusion and after the cutting wedge has come in contact with the inclusion, it can be concluded that there was a break of the tip of the cutting wedge because of the visible "furrows" on the part of the surface after the procedure, which is a consequence of a breakage of the cutting wedge, that is, the consequence of the change in the geometry of the cutting wedge. One such procedure leads to the stopping of the machining process because the said part is machined on the CNC machines in the automated unfolding of the process, and it is necessary to replace the tool (cutting blades or install another tile if all its tips are damaged).

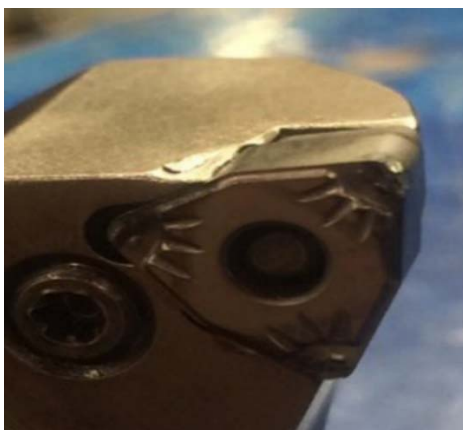
*Slika 4. Izgled polomljenog vrha pločice*  
*Figure 4. The appearance of the broken top of the tile*

Na slici 4. su prikazane neke od pločica koje su bile u zahvatu sa takvim otkovkom gdje se vidi izgled polomljene pločice. Od čega zavisi veličina loma pločice je teško utvrditi.

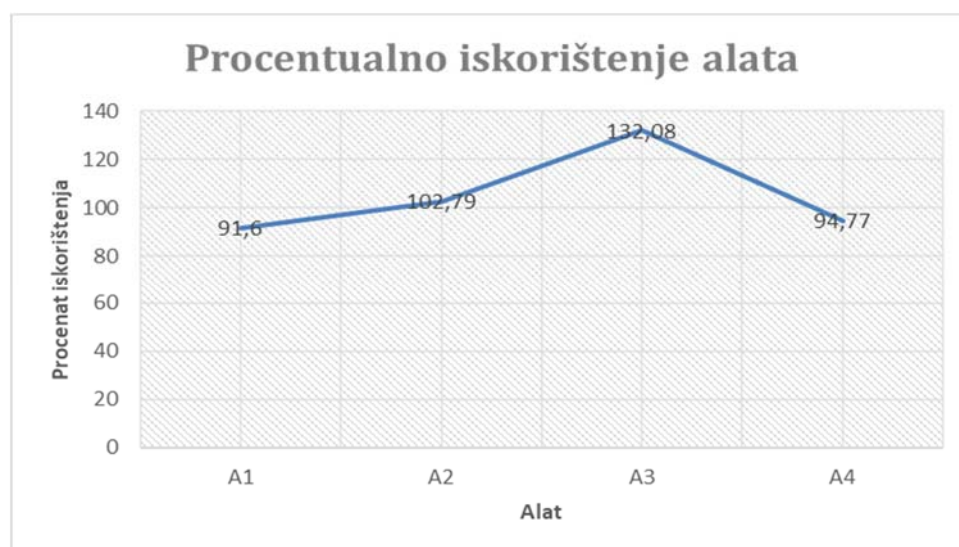
Grafikon 5. Procentualno iskorištenje alata

Chart 5. Percentage of tool utilization

Na grafikonu 5 je prikazano procentualno iskorištenje alata u posmatranom periodu od sedam dana.

Chart 5 shows the percentage utilization of tools in the observed seven-day period.
