FINDING THE ACTUAL CAUSES OF HYDRAULIC CYLINDER FAULT

Darko Lovrec, Vito Tič

The focus of the paper is searching for the actual cause of the frequently repeated failure of the closing cylinder on the plastic blow-moulding machine. The solution of the problem presented was the use of a combined approach: analysis of wear particles in the oil, and measurement of the accuracy of the motion of the cylinder's piston rod.

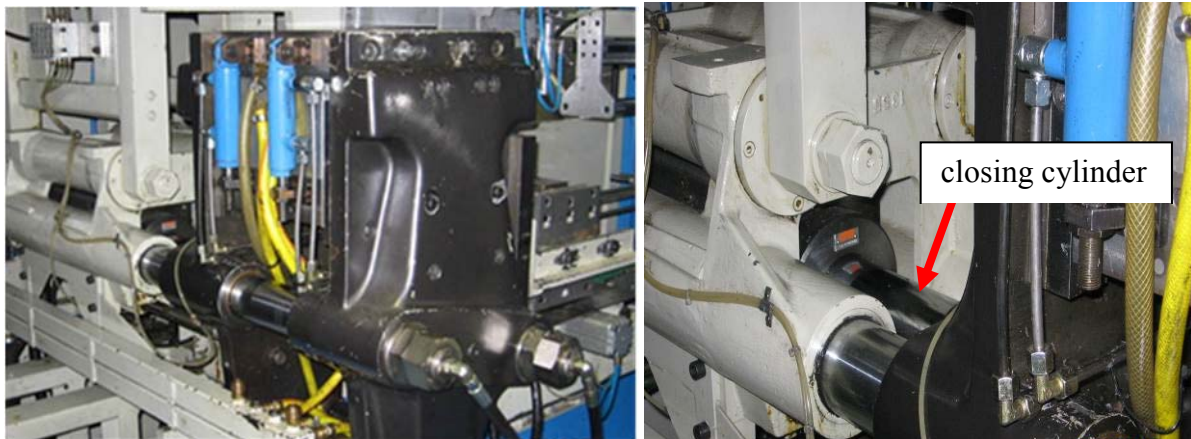
On the blow-moulding machine for production of plastic canisters with volume up to 5 L, a fault on the closing part of the machine occurred periodically. Opening and closing of the tools is carried out by means of a hydraulic cylinder with dimension of 125/80 (Figure 1).

Figure 1. Closing unit together with tool (left) and closing cylinder (right)

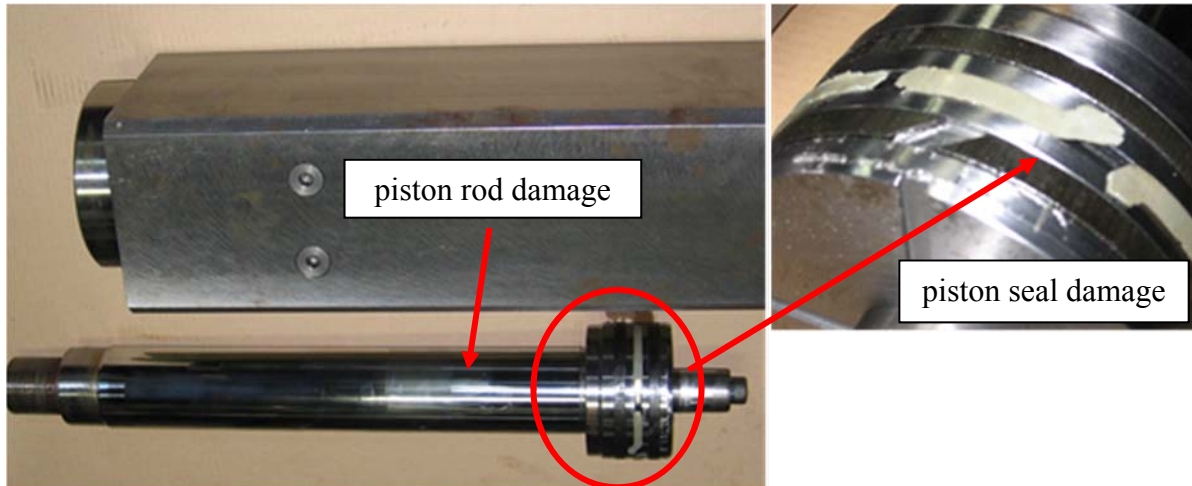
After dismantling, disassembly and detailed inspection of the cylinder, the consequences of wear on the inner surface of the cylinder were observed - the damaged surface of piston rod, cylinder (scratches), and damaged seals – Figure 2.

Figure 2. Damages on the piston rod and the seal

Due to the extensive damages on hydraulic cylinder (see Figure 2): visible metal parts of wear, damaged seal... it is absolutely essential to check the condition of the hydraulic fluid, not only the cleanliness level of hydraulic fluid, but also the other parameters, for example, water content, hard particles... - a complete laboratory analysis of basic properties.

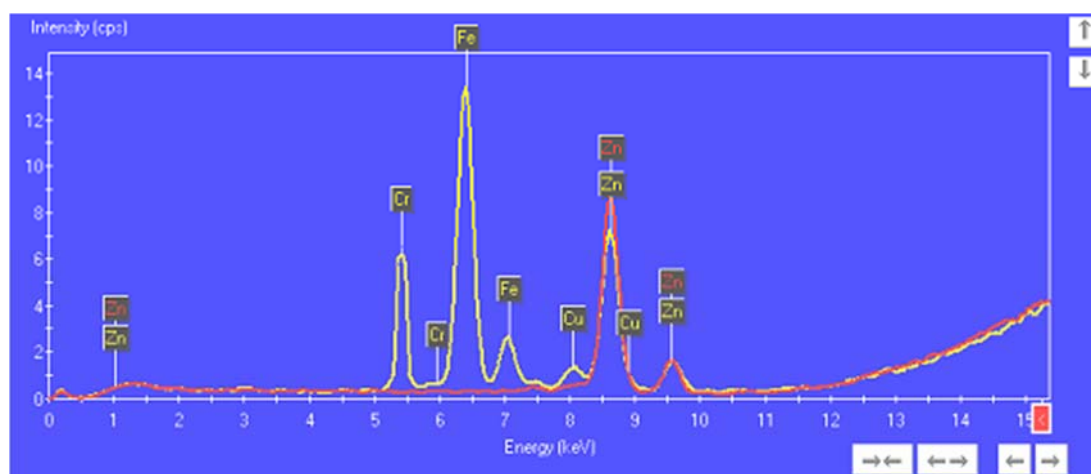
computer programme we can directly compare two spectra of the same fluid - the fresh and already used-up, heavy contaminated the same type of hydraulic oil - Figure 4.

Figure 4. Comparison of fresh (red spectrum, ISO 4406: 22/21/18) and used-up hydraulic oil (yellow spectrum, ISO 4406: >24/24/19)

On both spectra presence of wear particles respectively metal in hydraulic oil is evident. In case of fresh oil the particles of Zinc (Zn) are observable present, in case of used-up oil but beside Zinc as well Iron (Fe), Chromium (Cr) and Copper (Cu). It is known that Zinc is present as an oil additive element, therefore present on both spectra. Comparing their peaks by used-up oil, its intensity is lower, because of consumption this additive in oil.

The presence of all the other elements, as a deviations in intensity the spectra, are only the consequence of the wear processes. This information represents a very useful directive to look for place or component, where are they generated.

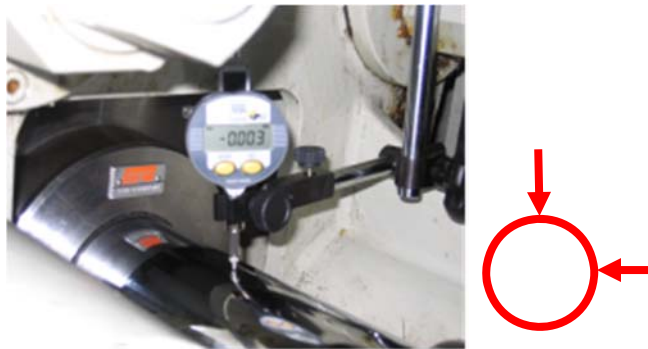
Due to the presence of excessive wear debris in particular iron and chromium, it was considered that the origin of this combination of damage to the piston rod of the hydraulic cylinder. The cause of the piston rod damage is certainly in the incorrect motion of the piston rod or/and the presence of side forces, which consequently lead to the wear of the piston rod (which is chromed) and the inner cylinder surface (iron). The presence of side forces during the piston motion was verified by measuring the uniformity of motion in two rectangular planes - Figure 5.

Figure 5. Motion accuracy measurement in two directions using precise gauge

On the basis of the measurements, it was found that a larger transverse displacement of the piston rod occurs at the end of the movement, when the tool is already closed and leans on the support point - in this case, on adjustable screw. The movement was inaccessible to 1,125 mm, which already led to the wear of the surface of the piston rod (visible to the naked eye) and

probably also the interior of the cylinder (the presence of Fe in the oil).

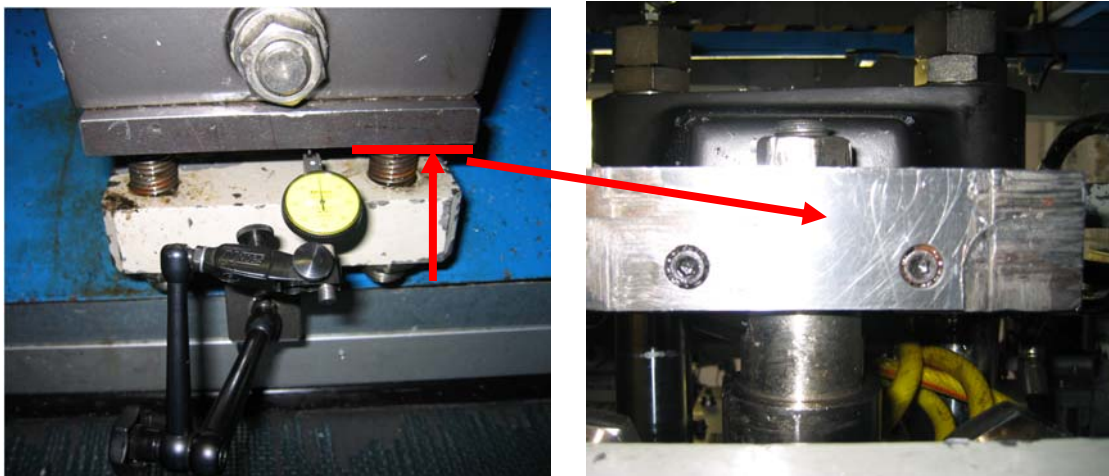
Why is the increased displacement of the piston rod near the end position? The reason is the incorrect adjustment of the support-screw, which also showed strong signs of wear - Figure 6.

Figure 6. Incorrect adjustment of the support-screw (left) and strong signs of wear (right)

Solving the problem was, in the end, quick, simple and cheap: correct, reinstalling the support screw and re-control with the measurement prevented the worst: further damage of hydraulic cylinder and stopping the machine.
